PENNSYLVANIA  
**BENTLEYVILLE DAM LEVEL II**

NDI ID NO. PA-1096

PHASE I INSPECTION REPORT  
NATIONAL DAM INSPECTION PROGRAM

L. ROBERT KIMBALL & ASSOCIATES  
CONSULTING ENGINEERS & ARCHITECTS  
EBENSBURG, PENNSYLVANIA  
15931

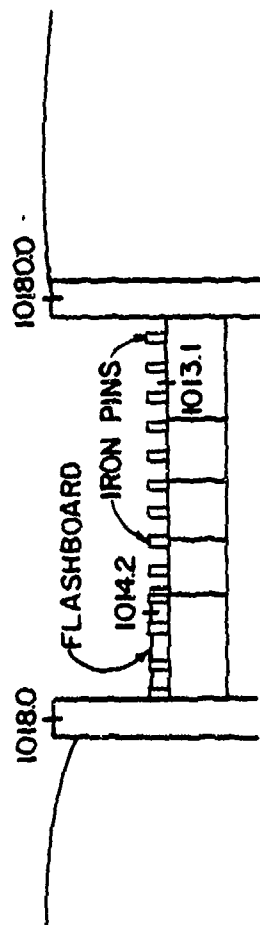
SPILLWAY CREST  
LOOKING UPSTREAM  
SCALE: 1"=10'

c. Appurtenant Structures. The spillway for the dam is located at the left abutment of the structure. An abandoned foot bridge spans the spillway crest. The spillway was constructed of concrete and incorporated a step type design in the discharge channel. In general, the existing concrete in the spillway is in a deteriorating condition. In several areas along the spillway channel walls and spillway bottom, the concrete has deteriorated to such an extent that reinforcing steel was observed. Sections of the stepped concrete channel bottom have deteriorated to an extent that undercutting of the channel floor is occurring due to seepage under the concrete lining.

An irregular shaped concrete weir exists at the entrance to the spillway, and serves as the control structure. The channel width at the control section, between the spillway retaining walls, is 20 feet. The configuration of the control section is such that the effective length of the weir is 25 feet. Steel bars exist along the crest of the control section and are utilized for the placement of flashboards. Only one flashboard was observed on the crest of the control section during the November 5, 1980 inspection. No flashboards were observed during the May 12, 1981 inspection.

3. The spillway is in a deteriorating condition. The concrete in the channel walls and channel bottom should be repaired.

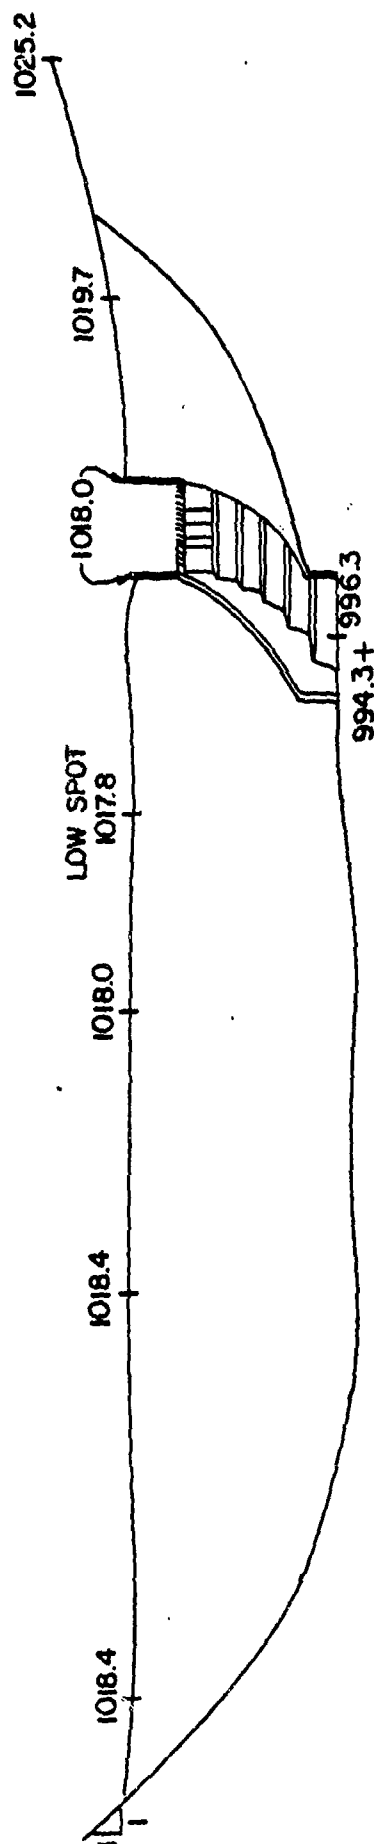
PROFILE  
LOOKING UPSTREAM  
SCALE: HORIZ. 1"=40'  
VERT. 1"=20'

b. Dam. The dam appears to be in poor condition. From a brief survey conducted during the inspection, it was noted that the low spot on the crest of the dam was located approximately 50 feet from the spillway. Riprap was observed on the upstream slope of the structure, and it was noted that some riprap was missing in several areas. The crest and slopes of the dam were grass covered. Brush and small trees were observed on both the upstream and downstream slopes. A small erosion area was observed adjacent to the right spillway wingwall. Wet areas were observed on the downstream slope adjacent to the right abutment contact, and a small wet area was observed on the downstream slope adjacent to the right spillway discharge channel wall, approximately 10 feet below the crest of the dam. No visible flow was observed at either wet area.
